Public Works & Utilities  
Bridge Engineering  
**Fox Island Bridge**

Fox Island Community Presentation

# UBIT Inspection Report

Fox Island Bridge #26211-A

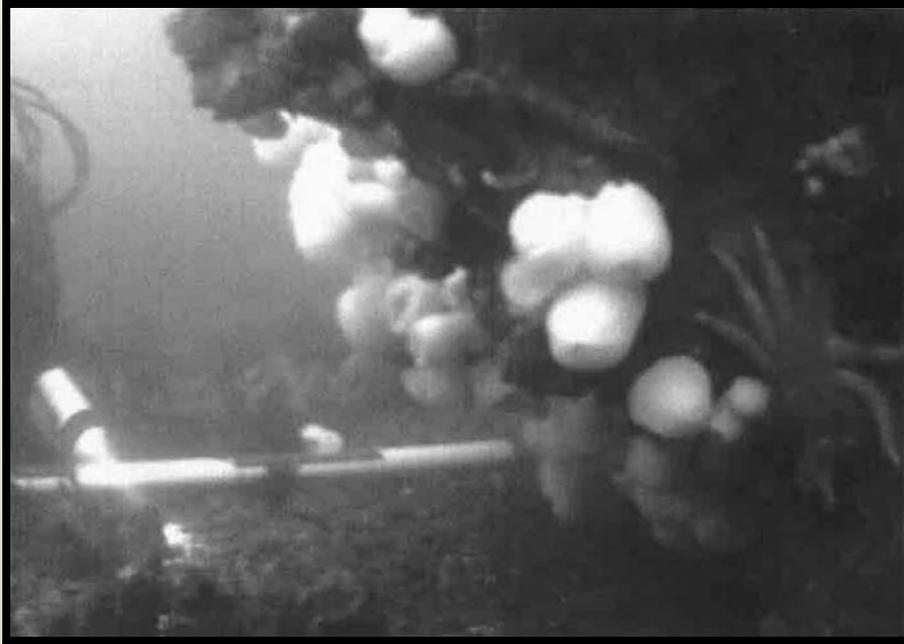
**SW corner of Pier 6 lens of poor consolidation measuring up to 2' vertical with up to 3.2' of penetration along the entire west face.**

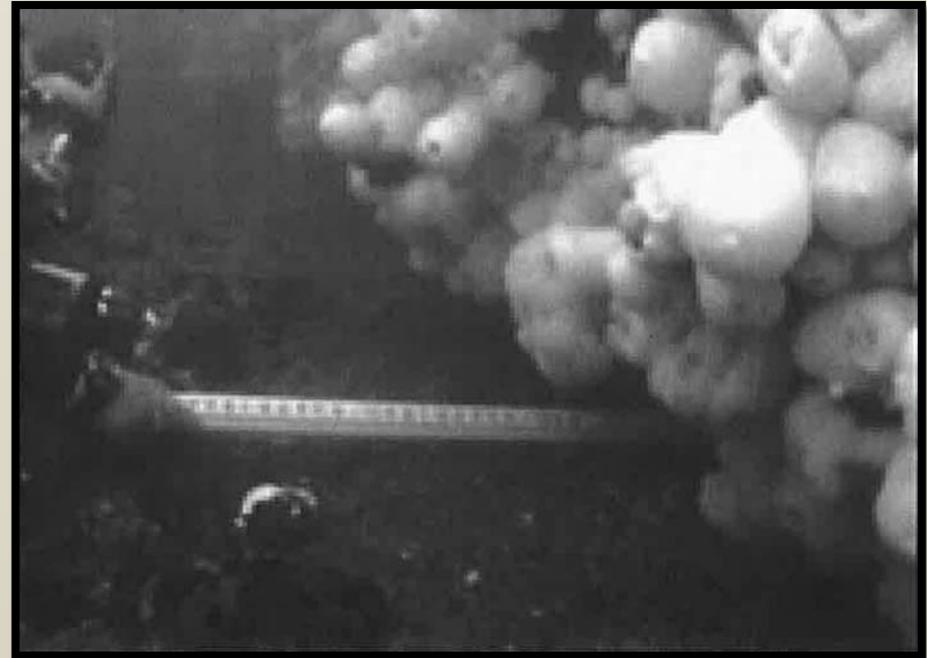
**Middle of Pier 6 lens of poor consolidation measuring up to 2' vertical with up to 3.2' of penetration along entire west face.**

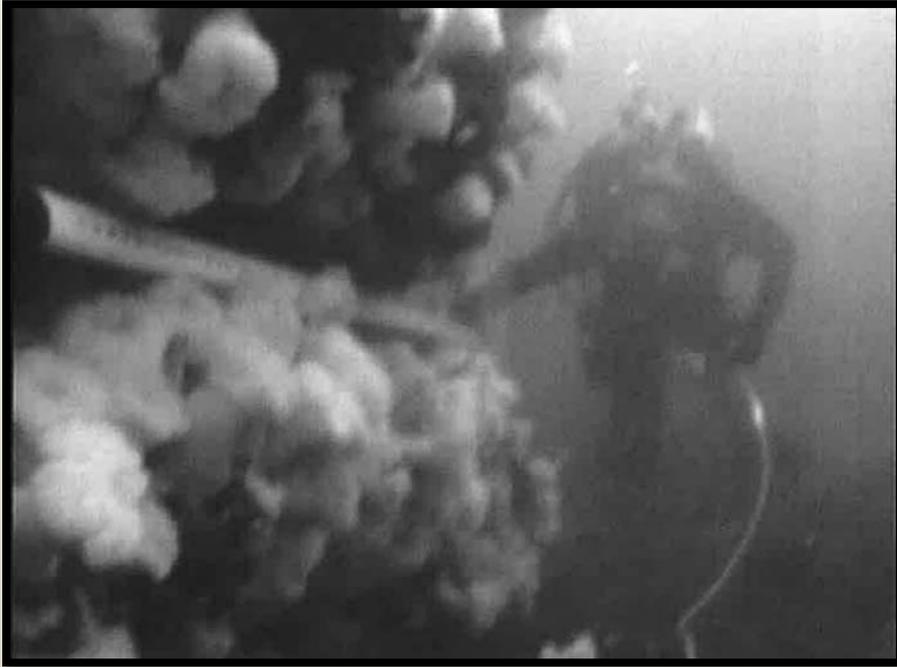
**Horizontal lens at NW corner of Pier 9 measured 8" tall with 6' of penetration. Looking west.**

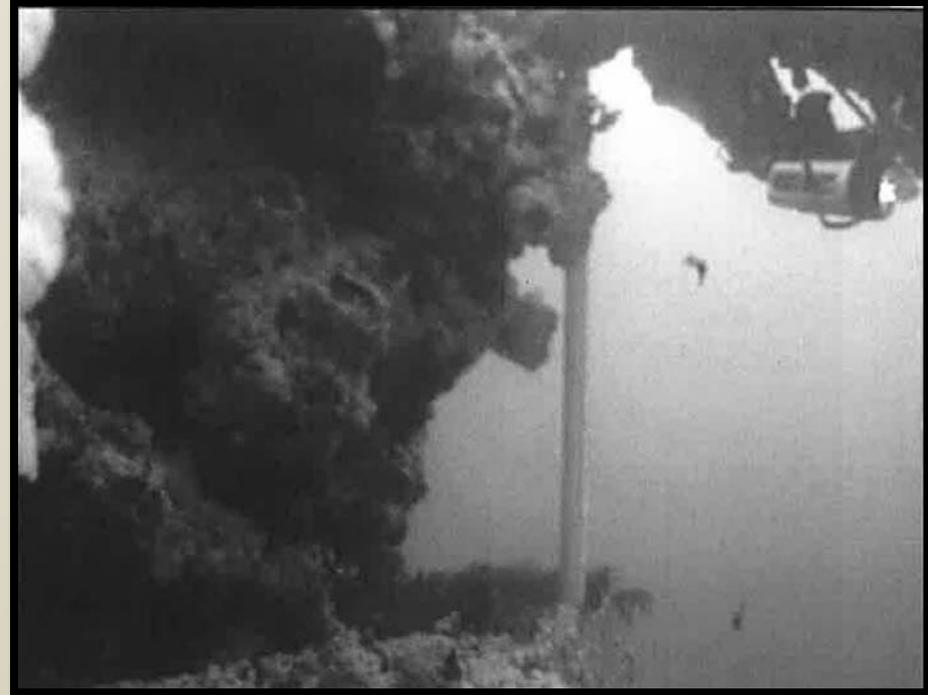
**Horizontal lens at NW corner of Pier 9 measured 8" tall with 6' of penetration. Looking west. Note the rod reading.**
