Clearance Inspection Checklist	
Job Number	16725
Project Name	DC Multiple Projects
Project Address:	930 Tacoma Ave South
Project area in facility:	930 building, suite 601
Client:	Pierce County Facilities Management
Client Job Number:	
Visual	
Visual Date and Time	10-Oct-2019 07:00
Area Cleaned & Wet Wiped?	Yes
Removal surfaces clean?	Yes
First layer of floor removed?	N/A
Lock down tinted?	N/A
Containment encapsulated?	N/A
Hard to reach/see areas inspected?	Yes
Repeat clean if Necessary	No
Visual Notes/Comments	All duct work mastic within scope of work has been fully abated.
Technician conducting visual:	Tyler Sadler
Technician signature

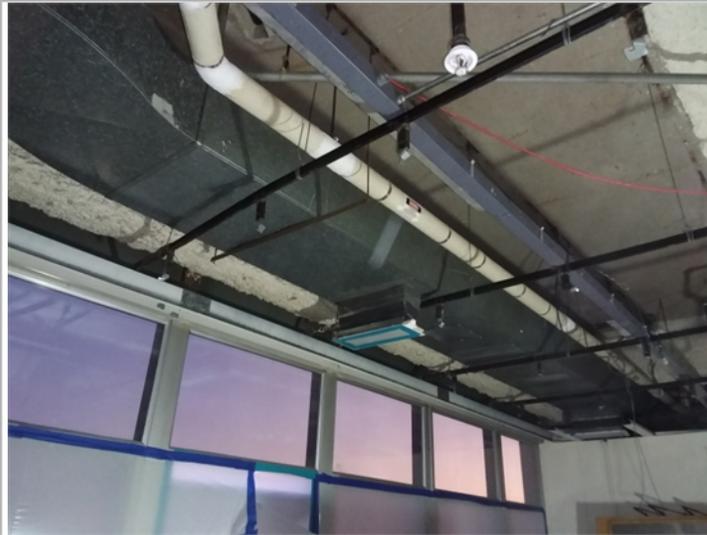
Area Photo:

Air Clearance	
Air Clearance -- Date and Time	10-Oct-2019 09:07
Clearance Air Sample Number(s):	1010-04 through 1010-07
Clearance Air Sample Result(s) (Fibers/cc):	F/CC=<0.004
Encapsulant applied and dry before air sampling?	N/A
Elapsed time since encapsulation:	N/A
Clearance below specified level?	Pass
