Project N19-0098

RE: Asbestos Inspection located at 950 Fawcett Avenue Tacoma, WA 98402

Limited Asbestos Survey Addendum #1
950 Building
950 Fawcett Avenue
Tacoma, WA 98402

PROJECT SPECIFIC ASBESTOS INSPECTION
950 RENOVATION PROJECT
950 Fawcett Ave.
Tacoma, Washington 98402

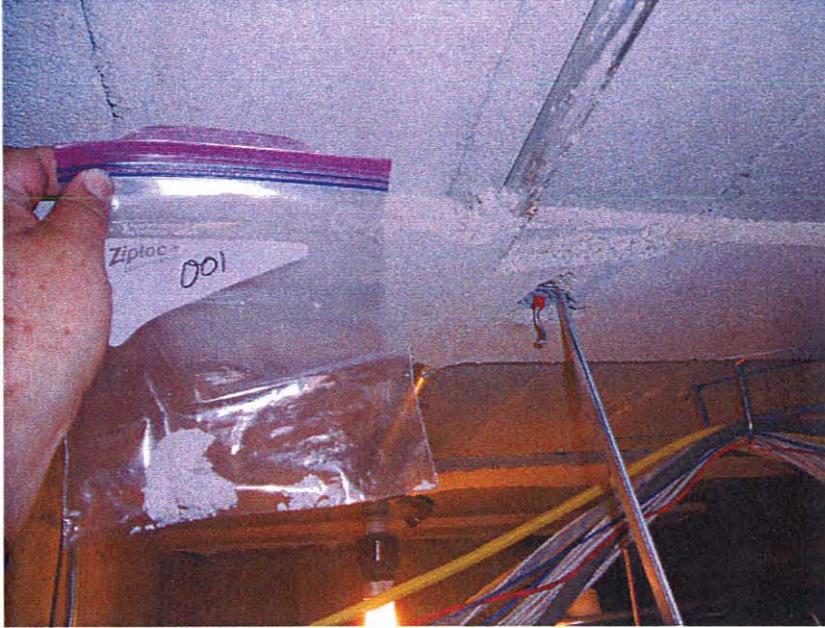
Description: Acoustical Plaster/Fireproofing

Material Location: Various

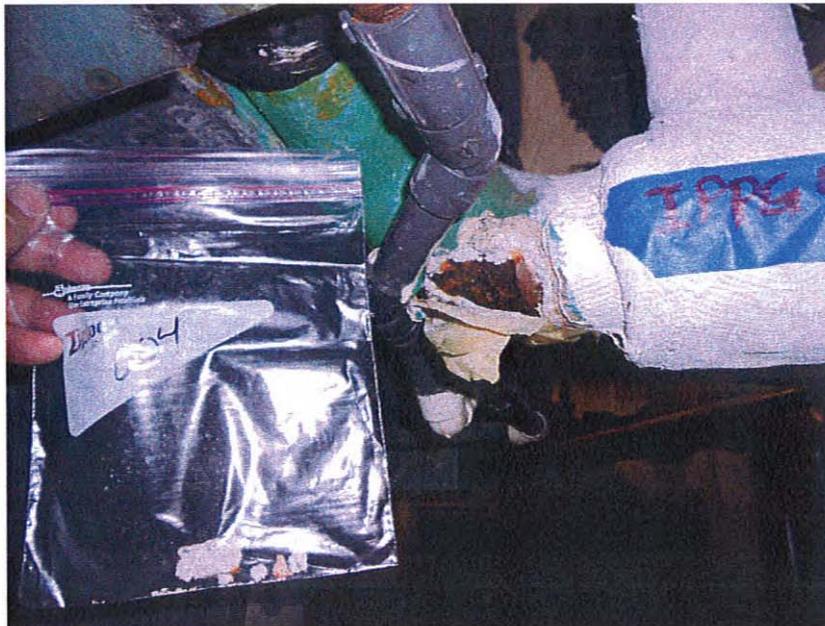
4" Mudded Fitting on Fiberglass Pipe Insulation

Description: Pipe Insulation

Material Location: Various

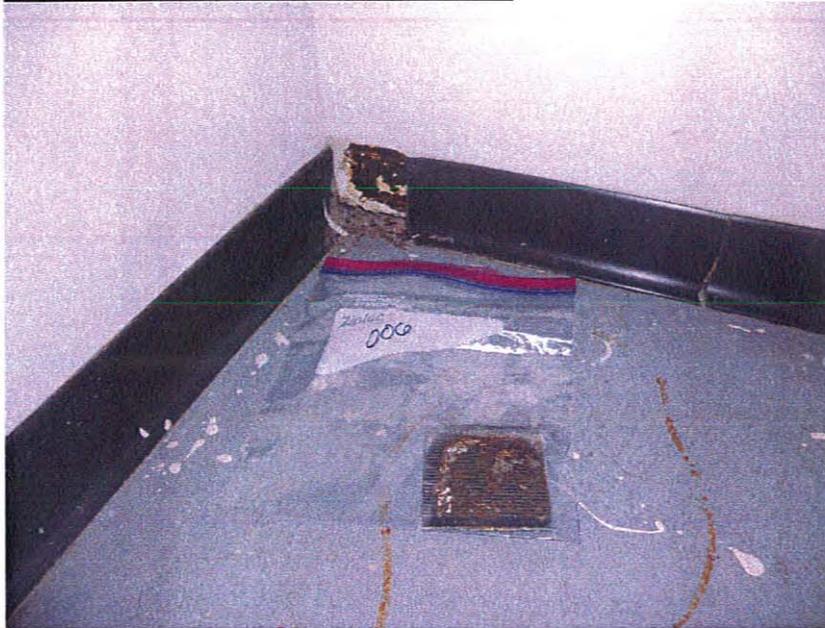
2" Black Cove Base and Brown Brittle Mastic

Description: Cove Base and Mastic

Material Location: Basement

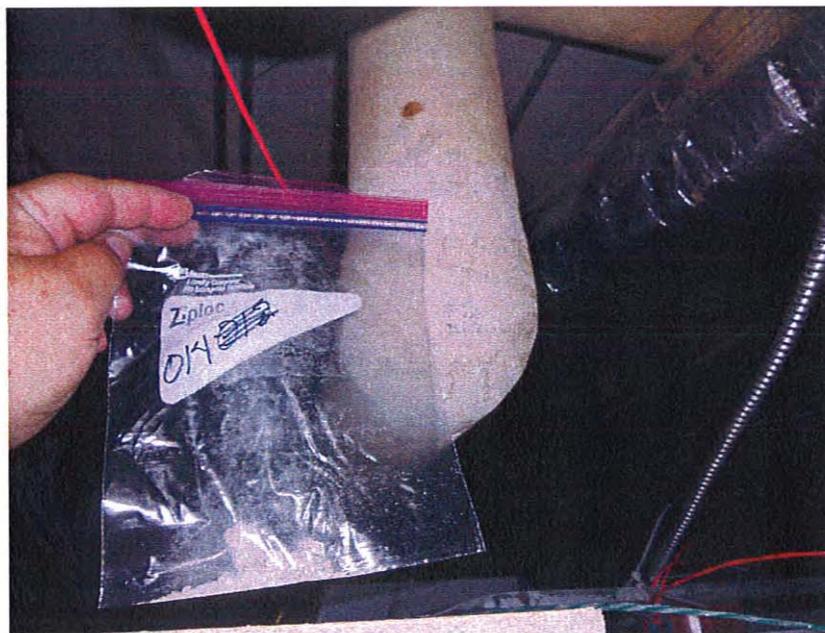
6" Mudded Fitting on Fiberglass Pipe Insulation

Description: Pipe Insulation

Material Location: Various

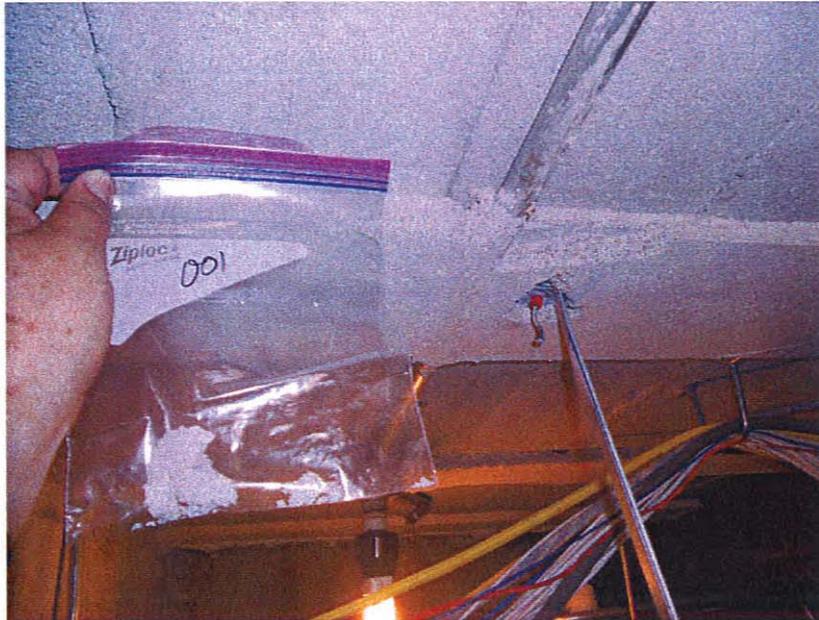
Description: Acoustical Plaster/Fireproofing

Material Location: Various

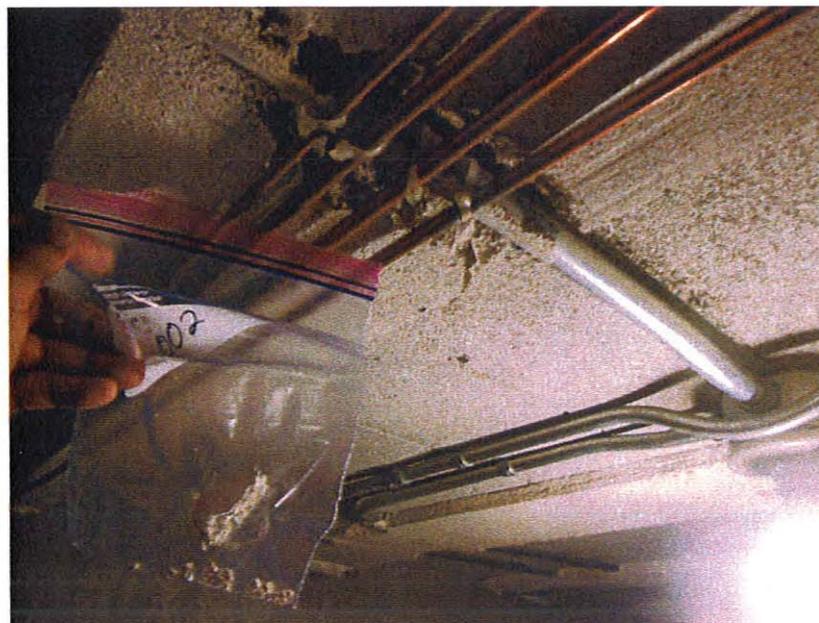
Description: Acoustical Plaster/Fireproofing

Material Location: Various

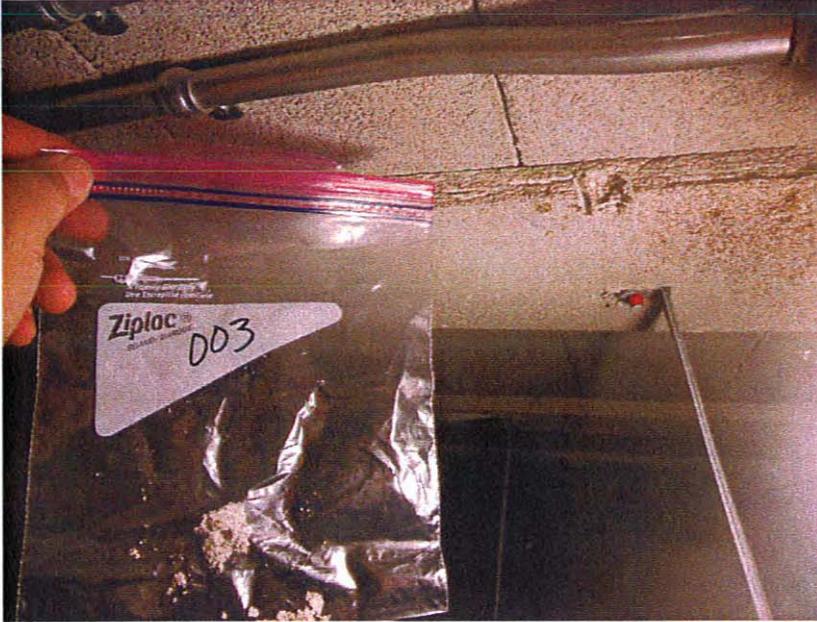
Description: Acoustical Plaster/Fireproofing

Material Location: Various

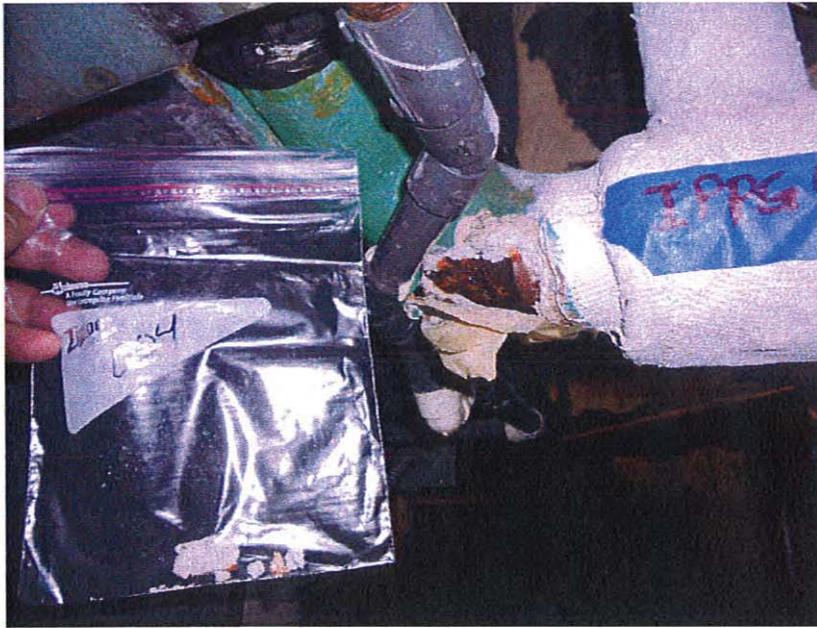
4" Mudded Fitting on Fiberglass Pipe Insulation

Description: Pipe Insulation

Material Location: Various

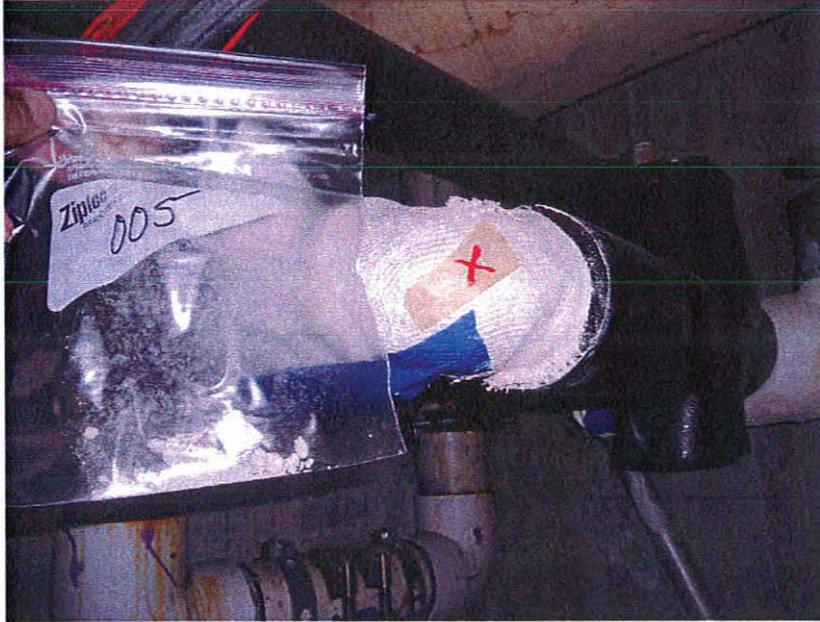
4" Mudded Fitting on Fiberglass Pipe Insulation

Description: Pipe Insulation

Material Location: Various

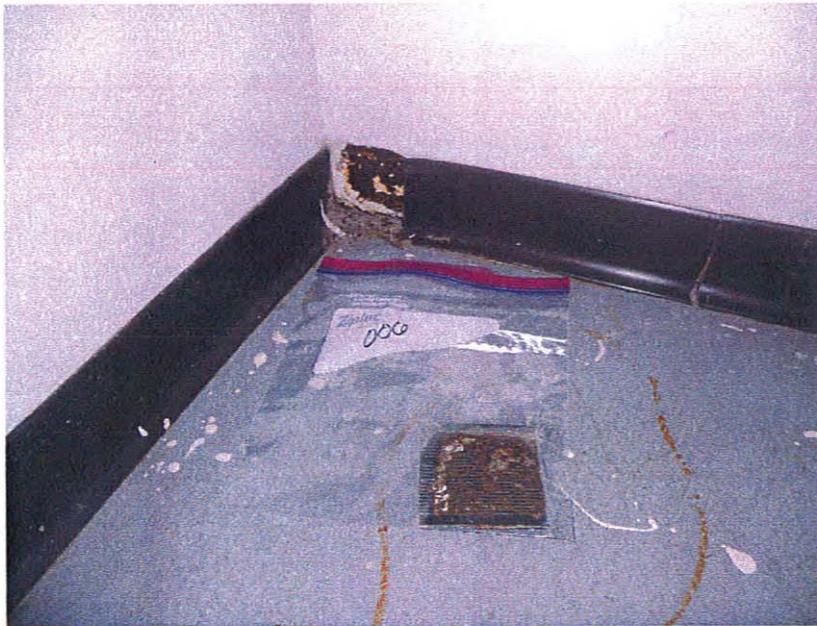
2" Black Cove Base and Brown Brittle Mastic

Description: Cove Base and Mastic

Material Location: Basement

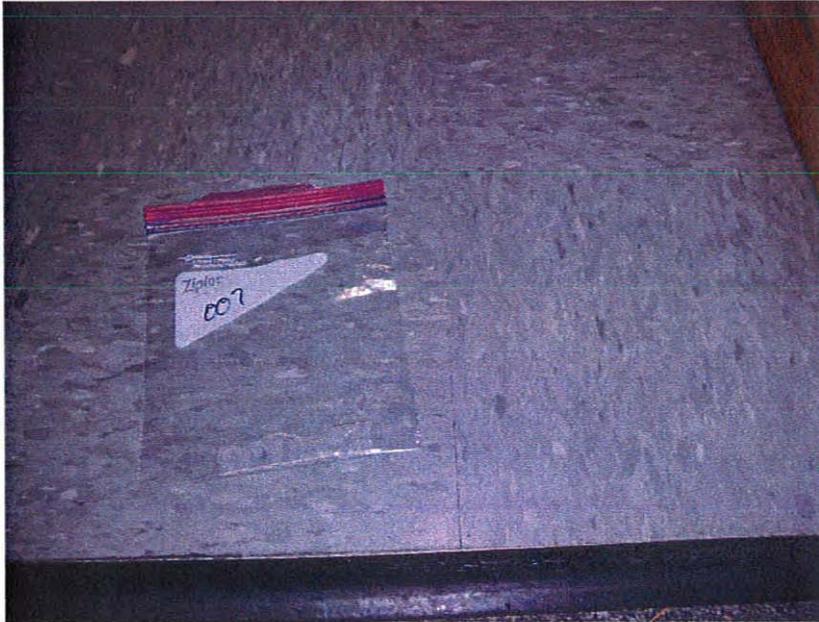
12"x12" Vinyl Floor Tile and Clear Mastic

Description: Floor Tile and Mastic

Material Location: First Floor

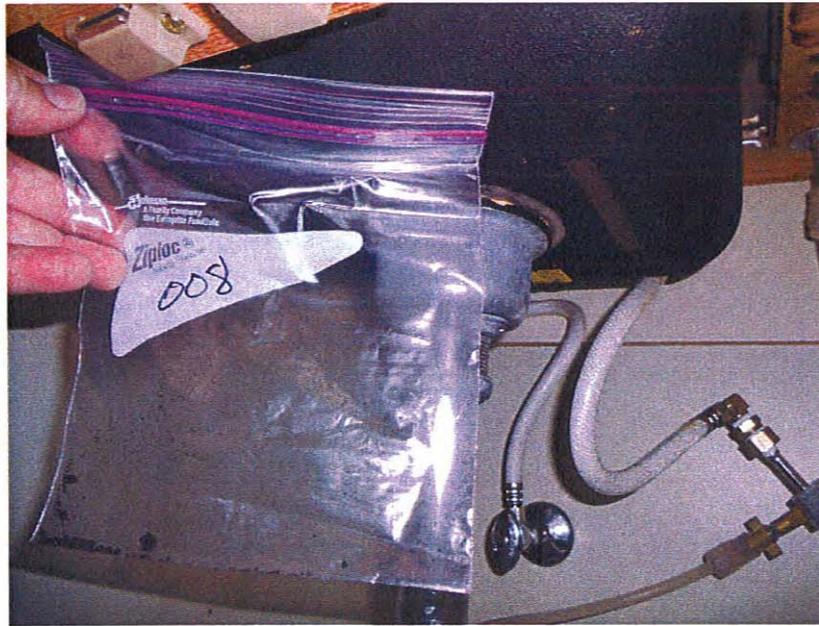
Dark Stainless Steel Sink Insulation

Description: Sink Insulation

Material Location: First Floor

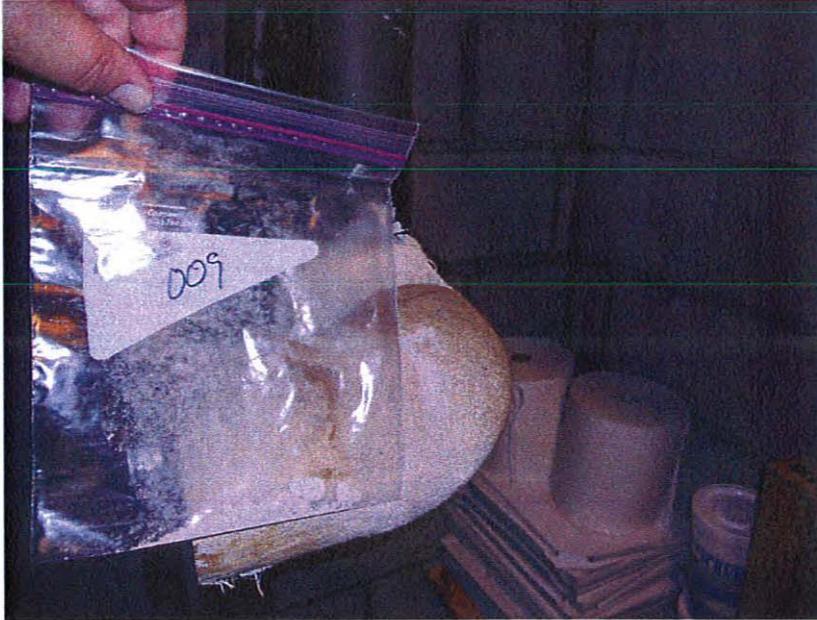
6" Mudded Fitting on Fiberglass Pipe Insulation

Description: Pipe Insulation

Material Location: Various

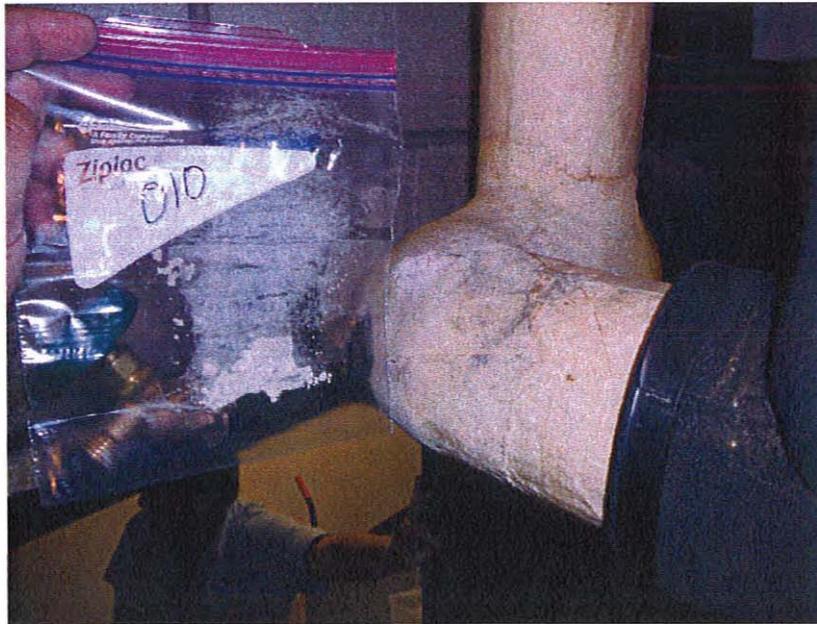
6" Mudded Fitting on Fiberglass Pipe Insulation

Description: Pipe Insulation

Material Location: Various

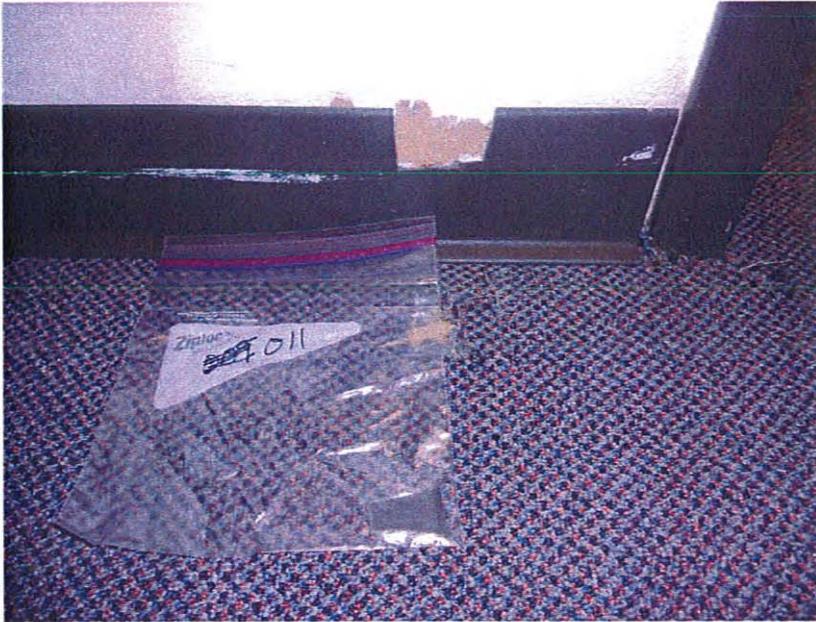
4" Brown Cove Base and White Mastic

Description: Cove Base and Mastic

Material Location: Various

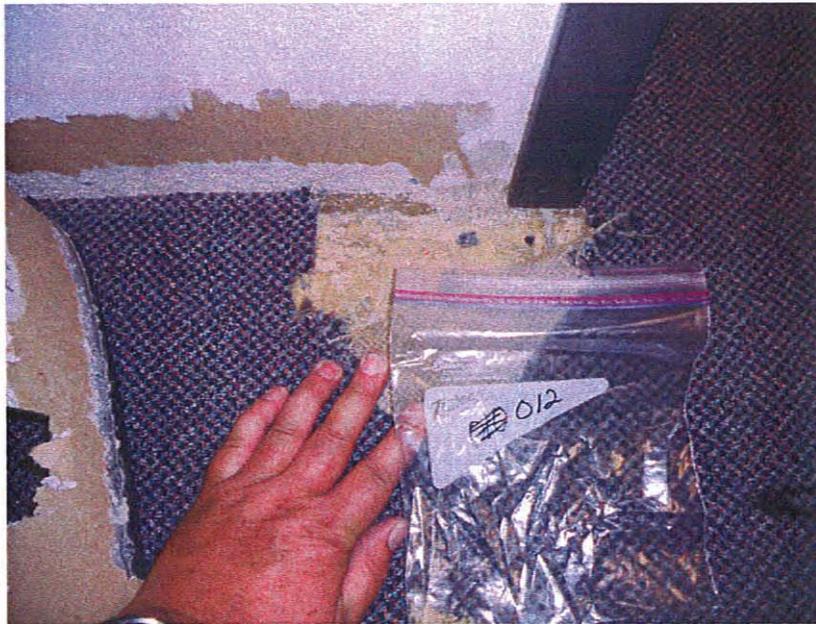
Yellow Carpet Mastic

Description: Mastic

Material Location: Various

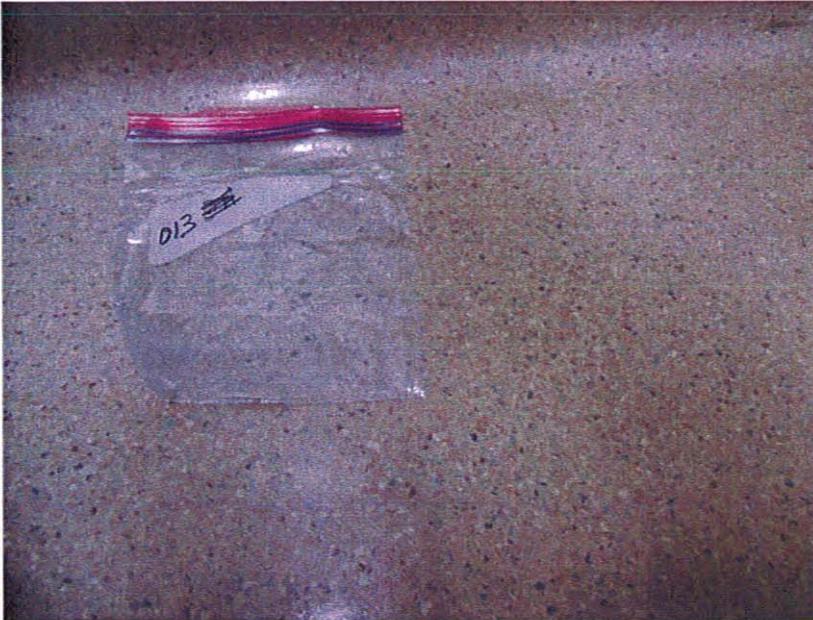
Sheet Vinyl, Pink Speckled

Description: Sheet Vinyl

Material Location: Restrooms

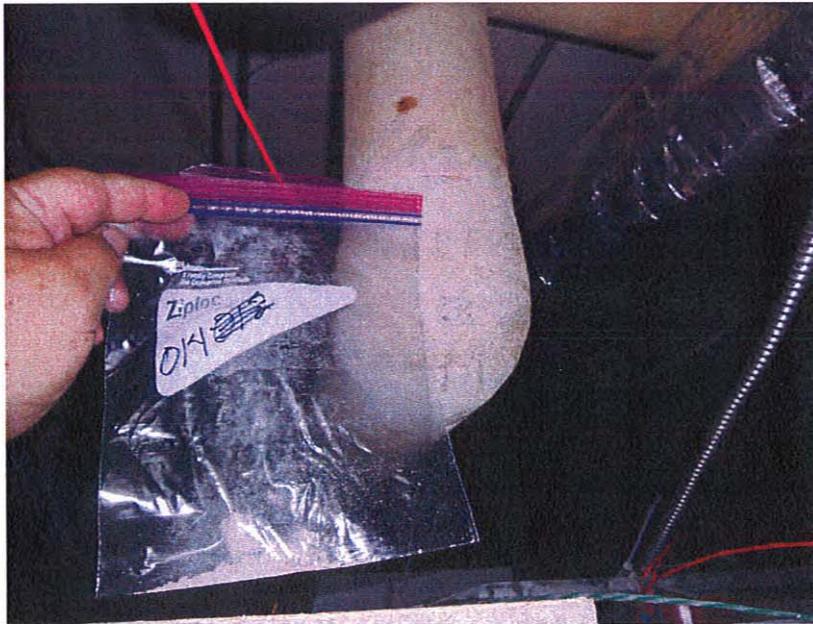
6" Mudded Fitting on Fiberglass Pipe Insulation

Description: Pipe Insulation

Material Location: Various

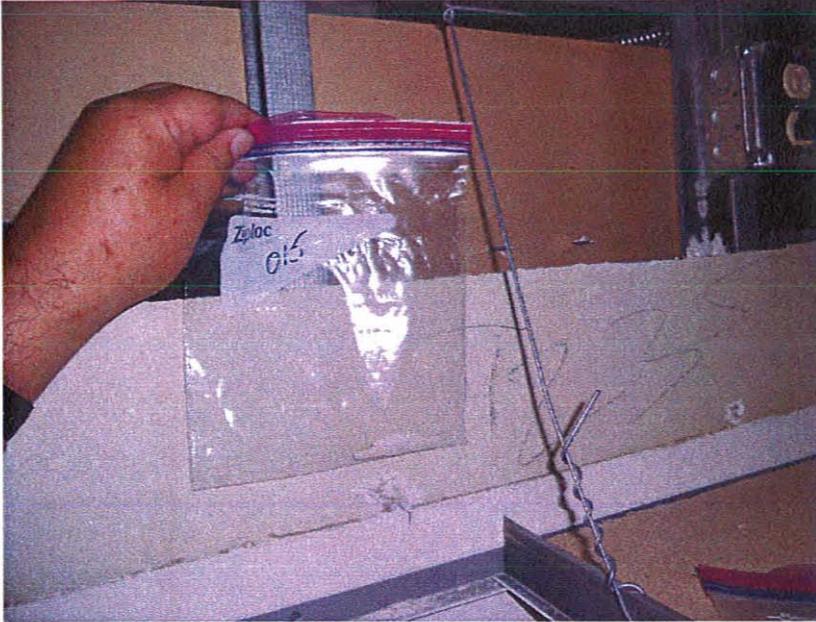
Texture and Joint Compound

Description: Wall System

Material Location: Various

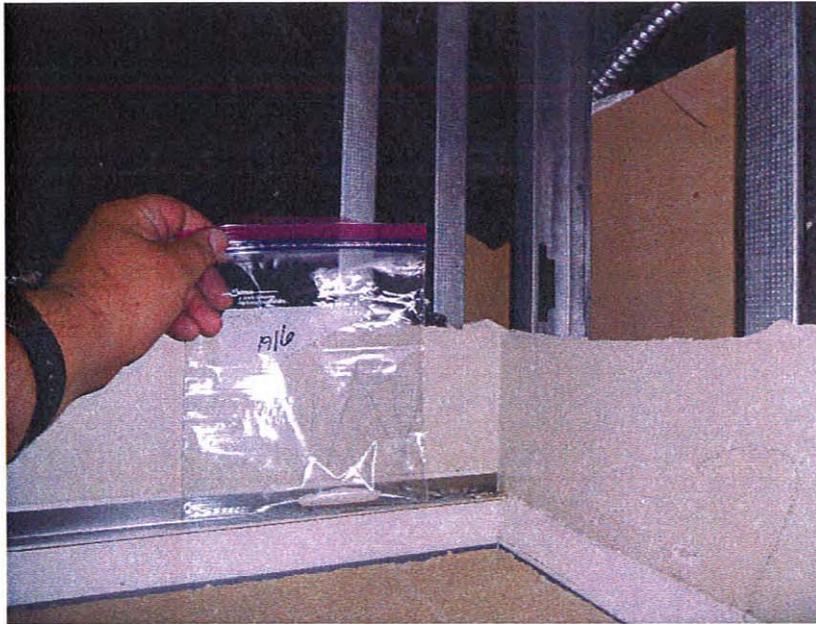
Texture and Joint Compound

Description: Wall System

Material Location: Various

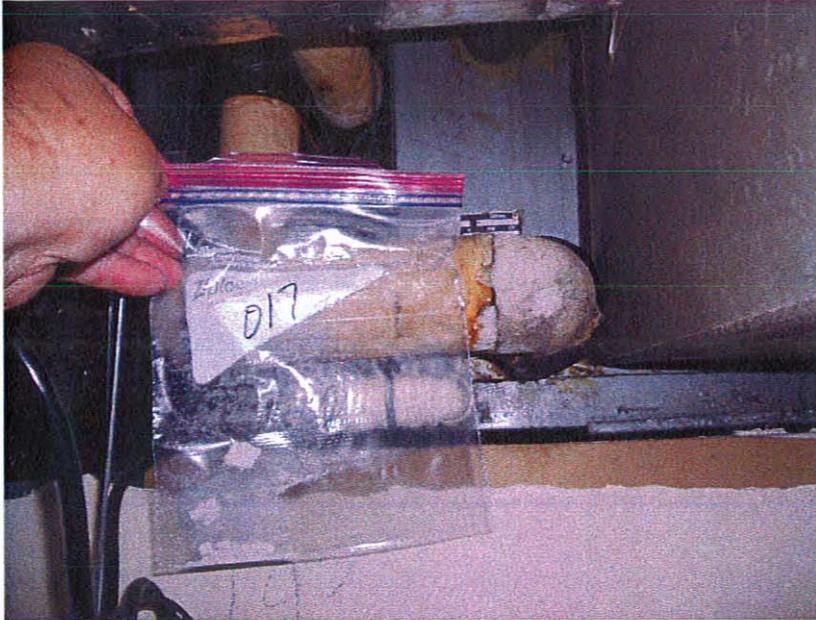
4" Mudded Fitting on Fiberglass Pipe Insulation

Description: Pipe Insulation

Material Location: Various

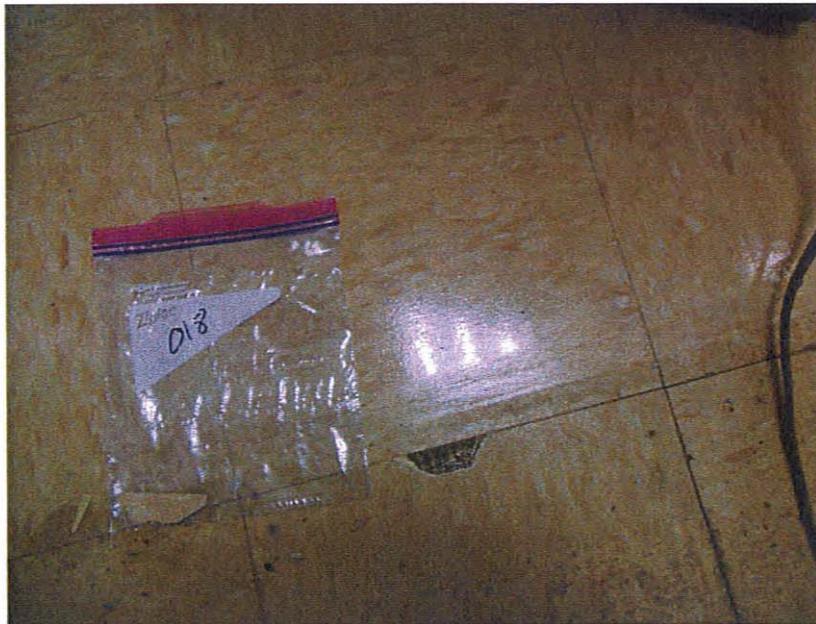
12"x12" Yellow Vinyl Floor Tile and Mastic

Description: Floor Tile and Mastic

Material Location: Kitchenette

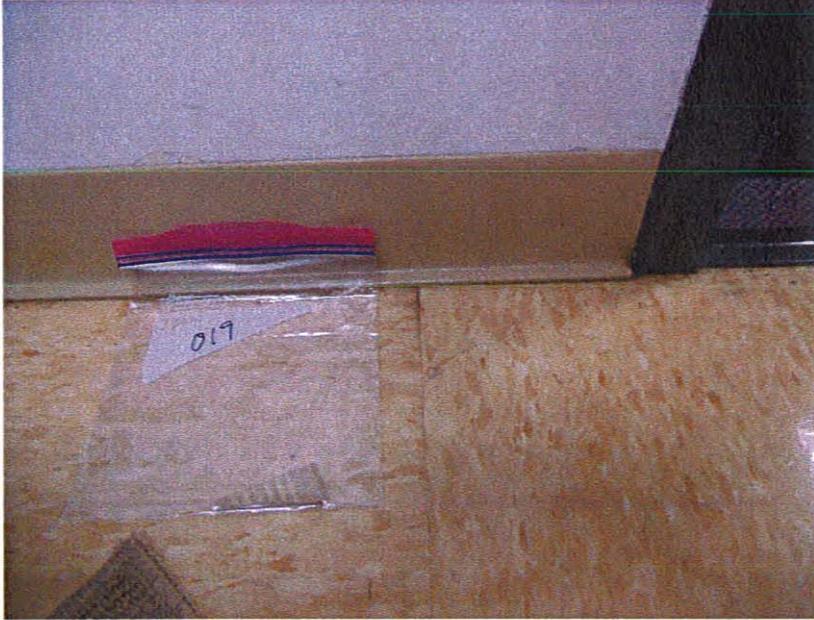
4" Tan Cove Base and White Mastic

Description: Cove Base and Mastic

Material Location: Kitchenette

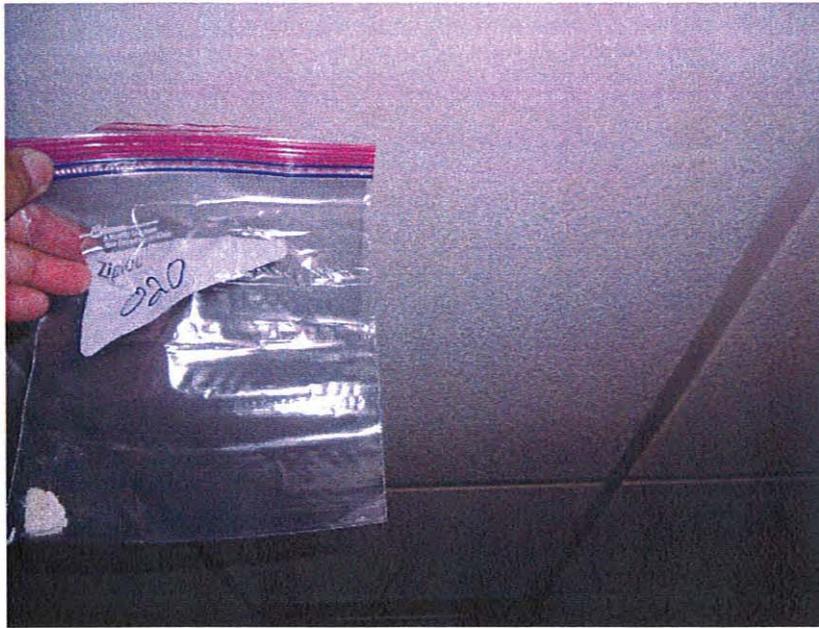
2'x4' White Ceiling Tile, Textured Pattern

Description: Ceiling Tile

Material Location: Third Floor

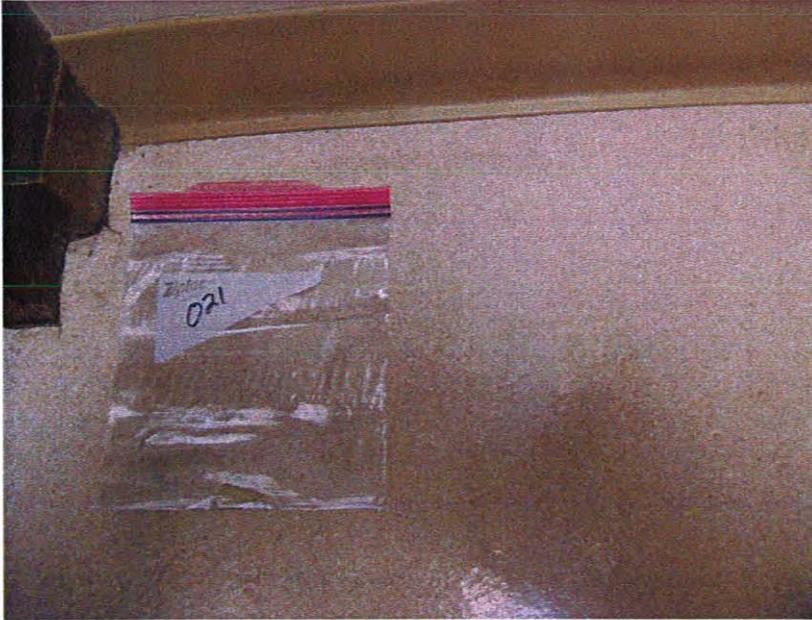
Sheet Vinyl, Yellow Sandy Pattern

Description: Sheet Vinyl

Material Location: Kitchenette

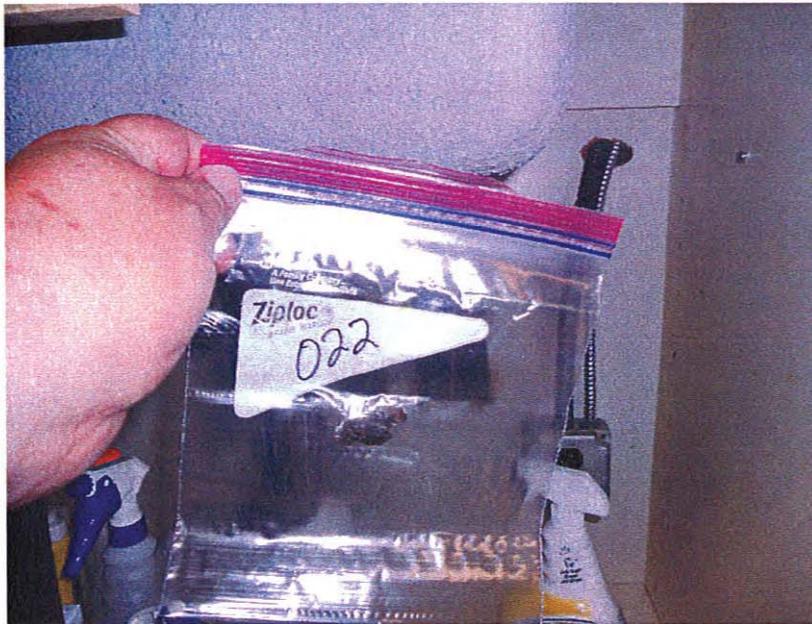
Gray Stainless Steel Sink Insulation

Description: Sink Insulation

Material Location: Kitchenette

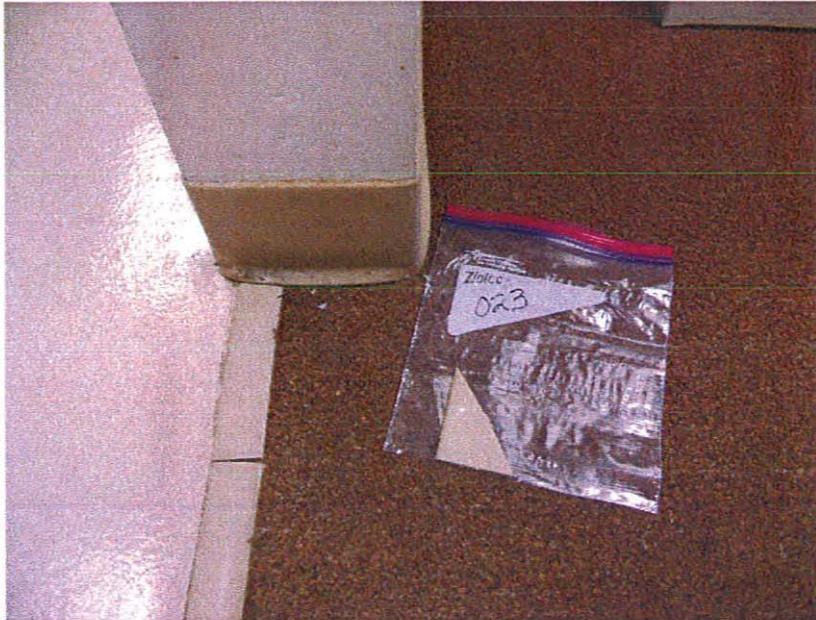
4" Cream Cove Base and Mastic

Description: Cove Base and Mastic

Material Location: Kitchenette

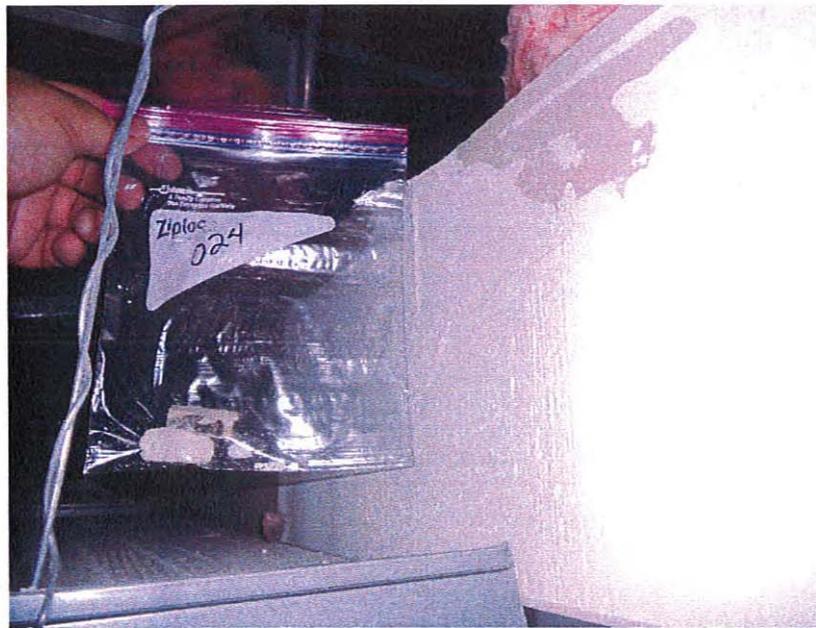
Joint Compound and Gypsum Wallboard

Description: Wall system

Material Location: Various

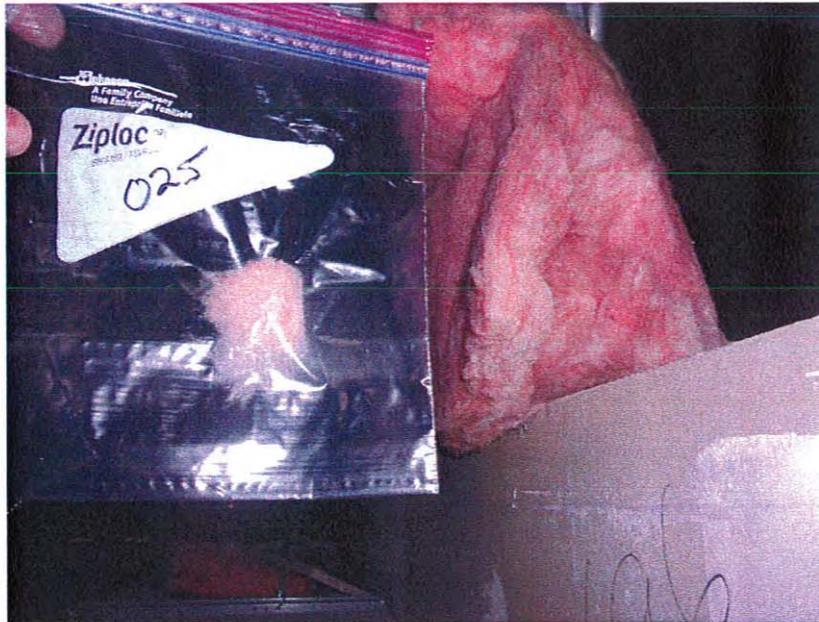
Pink Insulation

Description: Insulation

Material Location: Various

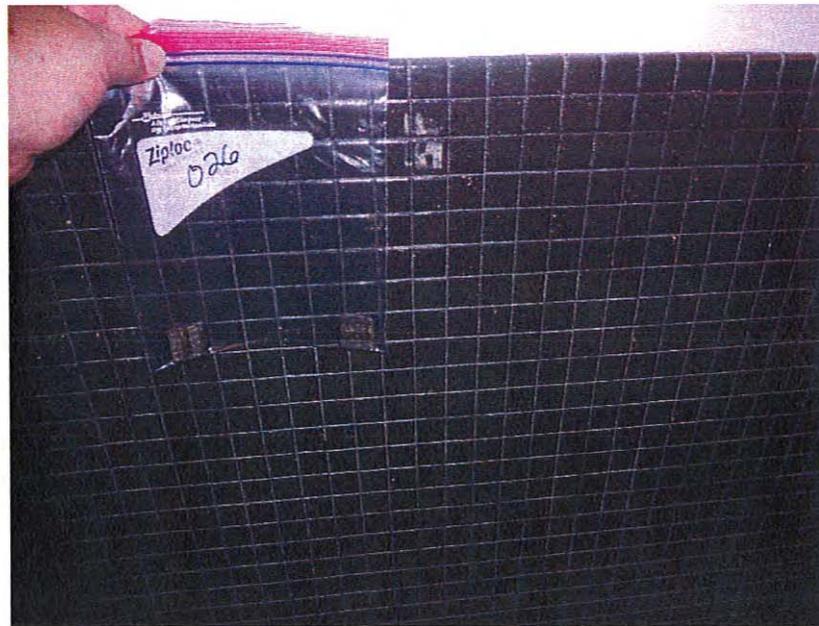
1"x1" Black Ceramic Tile and Black Grout

Description: Ceramic Tile

Material Location: Restroom

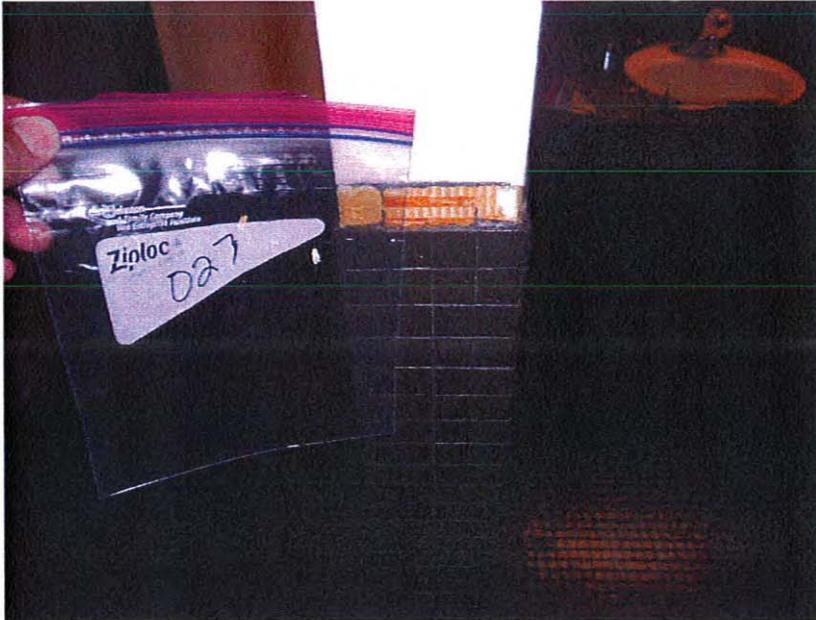
Yellow Mastic

Description: Mastic

Material Location: Restroom

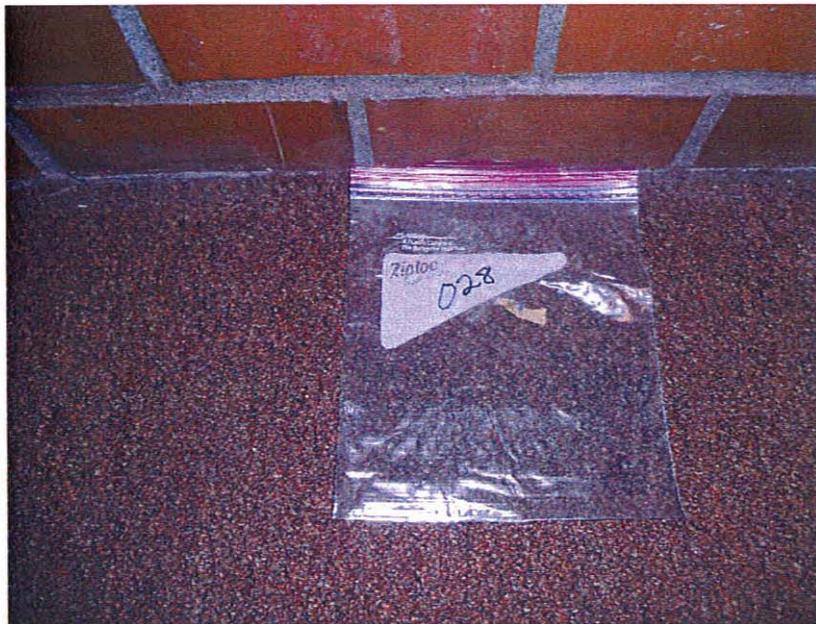
Yellow Gummy Carpet Mastic

Description: Mastic

Material Location: Various

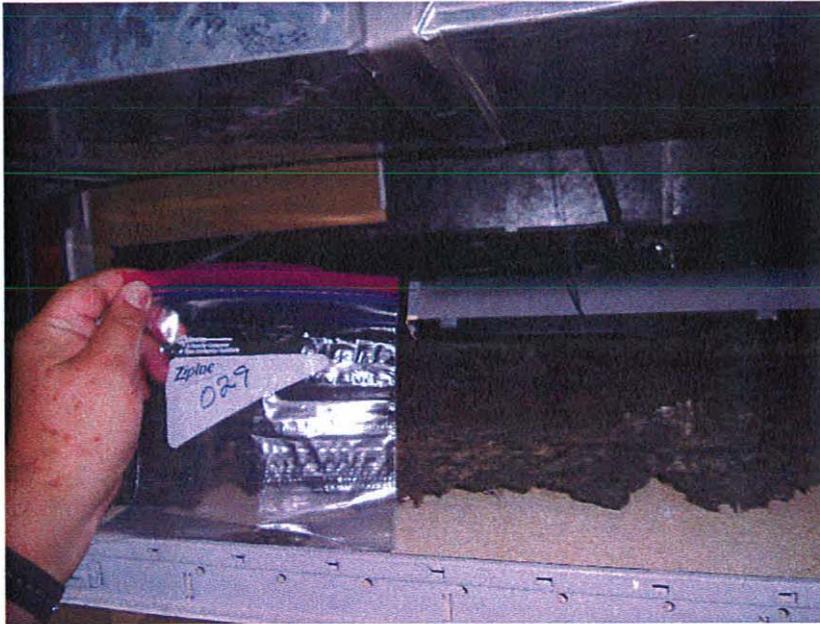
Black Insulation

Description: Insulation

Material Location: Various

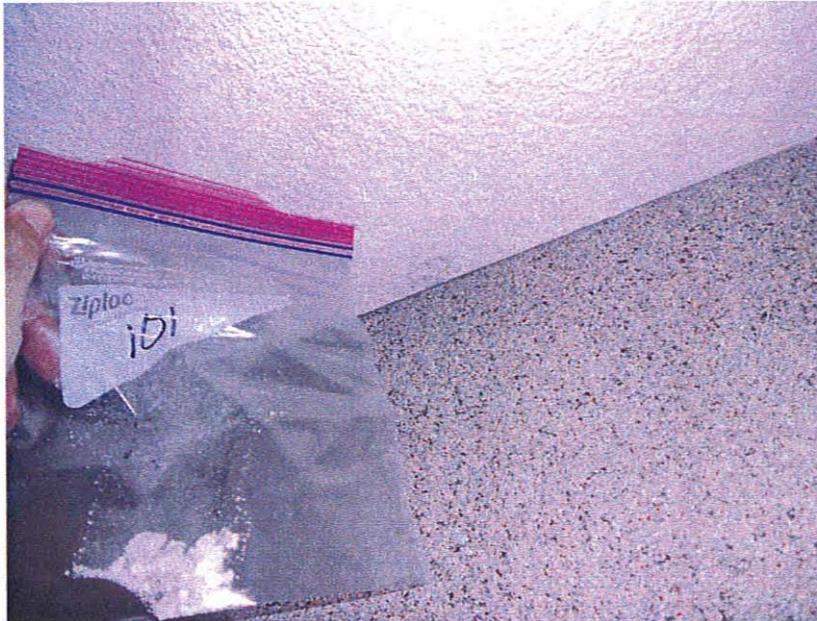
Description: Acoustical Plaster/Fireproofing

Material Location: Restroom

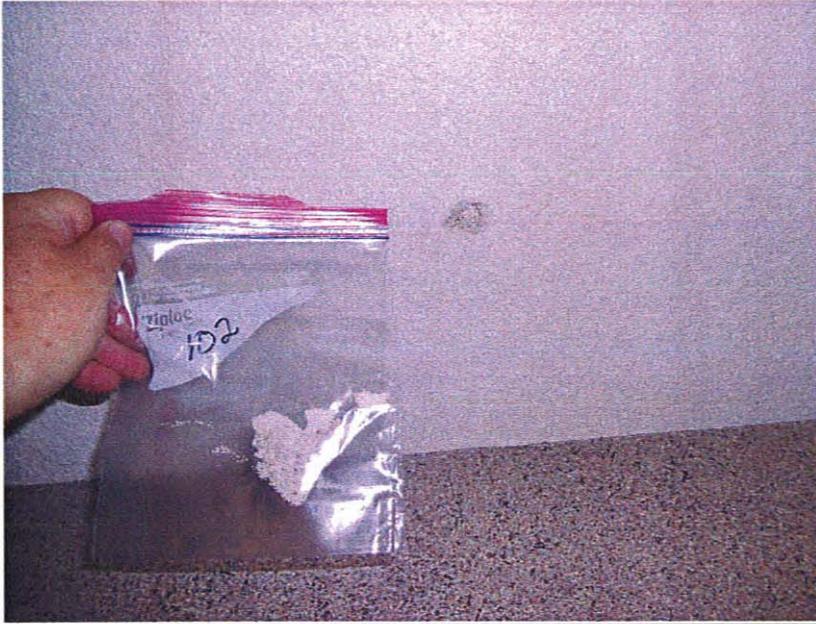
Description: Acoustical Plaster/Fireproofing

Material Location: Various

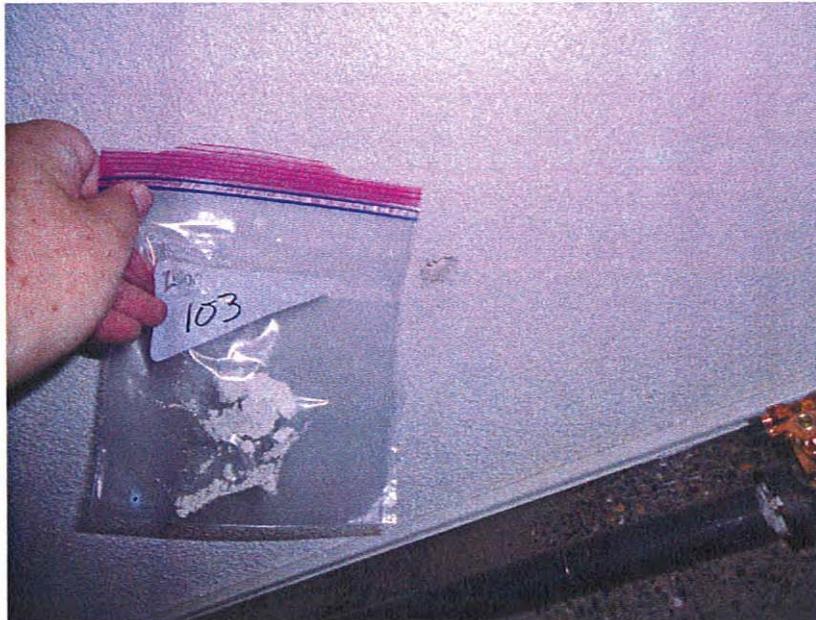
Description: Acoustical Plaster/Fireproofing

Material Location: Various

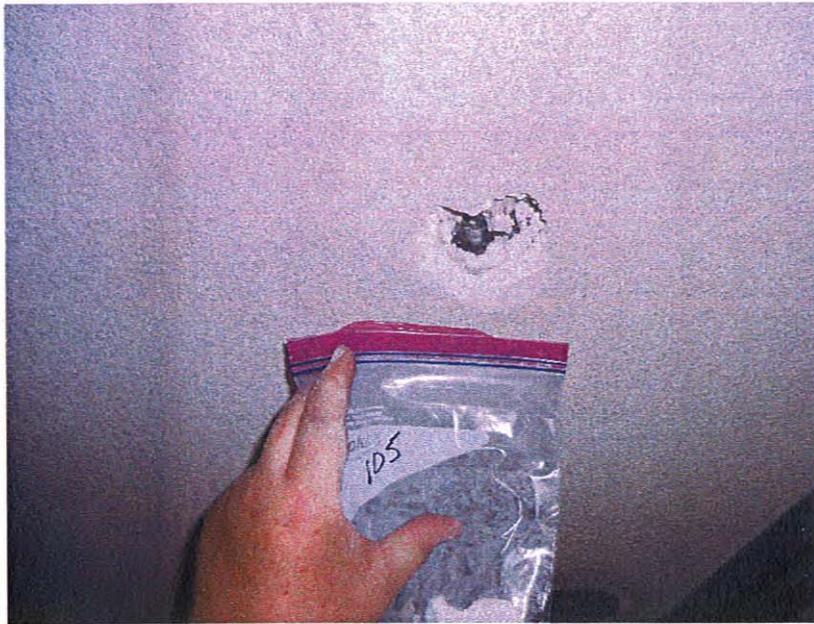
Hard Plaster over Gypsum Wallboard

Description: Wall System

Material Location: Various

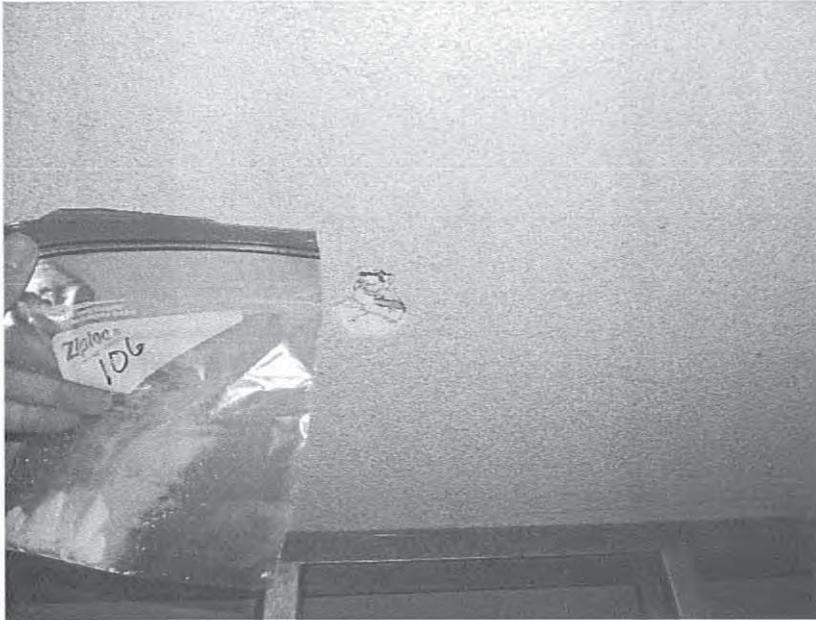
Hard Plaster over Gypsum Wallboard

Description: Wall System

Material Location: Various

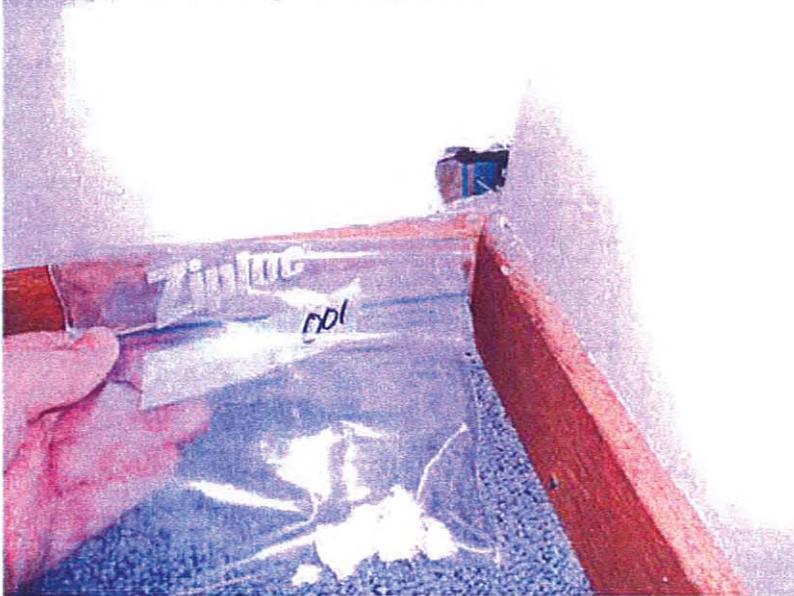
Wallboard and Associated Joint Compound

Description: Wall System

Material Location: First Floor Office

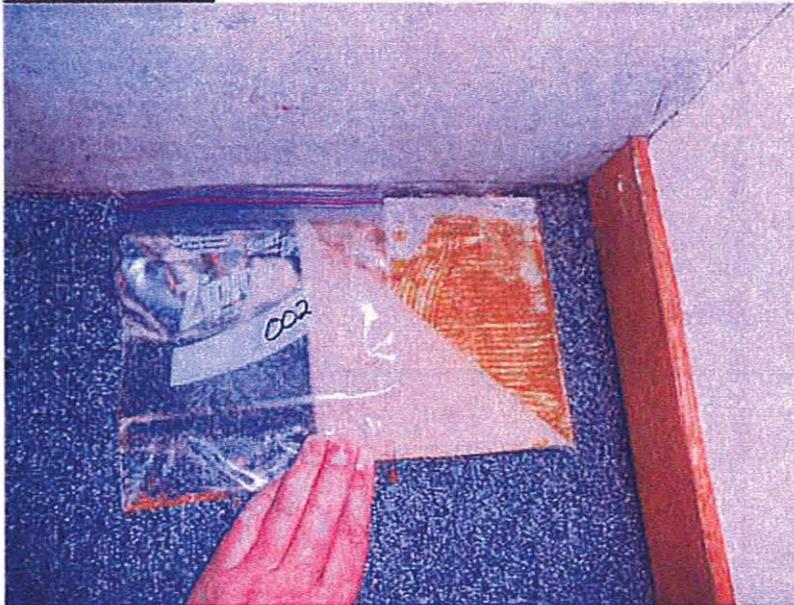
Gold Carpet Mastic

Description: Carpet Mastic

Material Location: First Floor Office

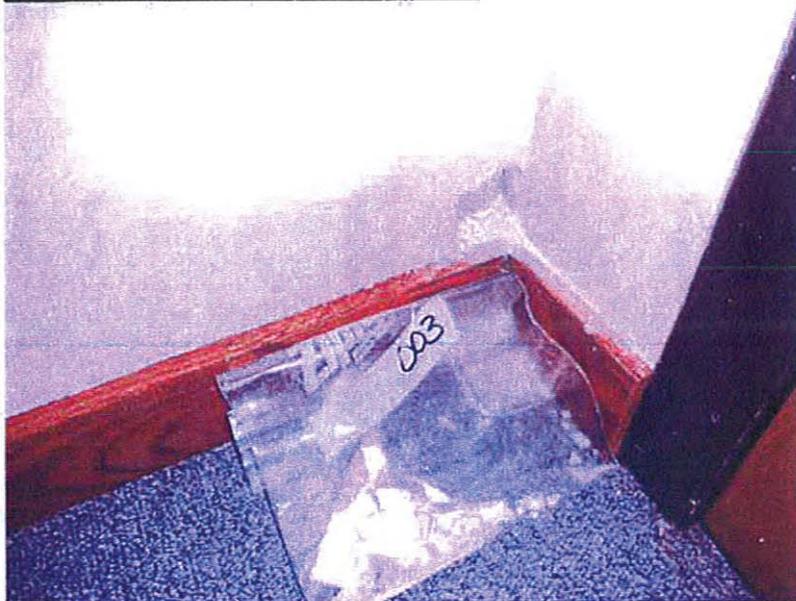
Wallboard and Associated Joint Compound

Description: Wall System

Material Location: First Floor Office

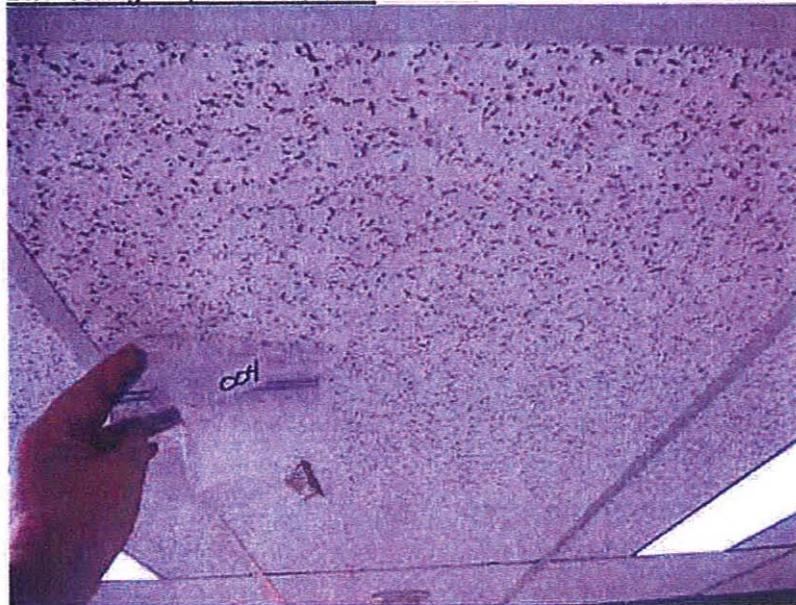
2'x4' Ceiling Tile, Random Pattern

Description: Ceiling Tile

Material Location: First Floor Office

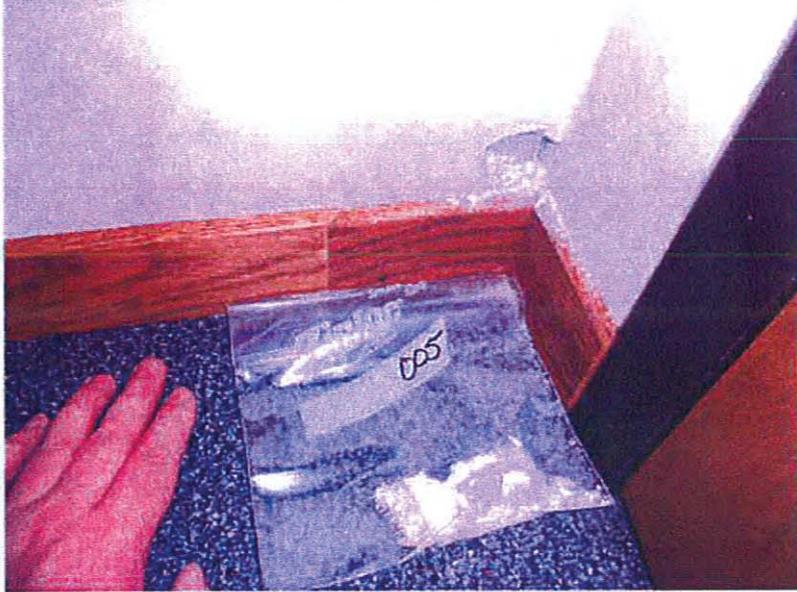
Wallboard and Associated Joint Compound

Description: Wall System

Material Location: First Floor Office
