Project N19-0098

RE: Asbestos Inspection located at 950 Fawcett Avenue Tacoma, WA 98402

Limited Asbestos Survey Addendum #1
950 Building
950 Fawcett Avenue
Tacoma, WA 98402

PROJECT SPECIFIC ASBESTOS INSPECTION
950 RENOVATION PROJECT
950 Fawcett Ave.
Tacoma, Washington 98402

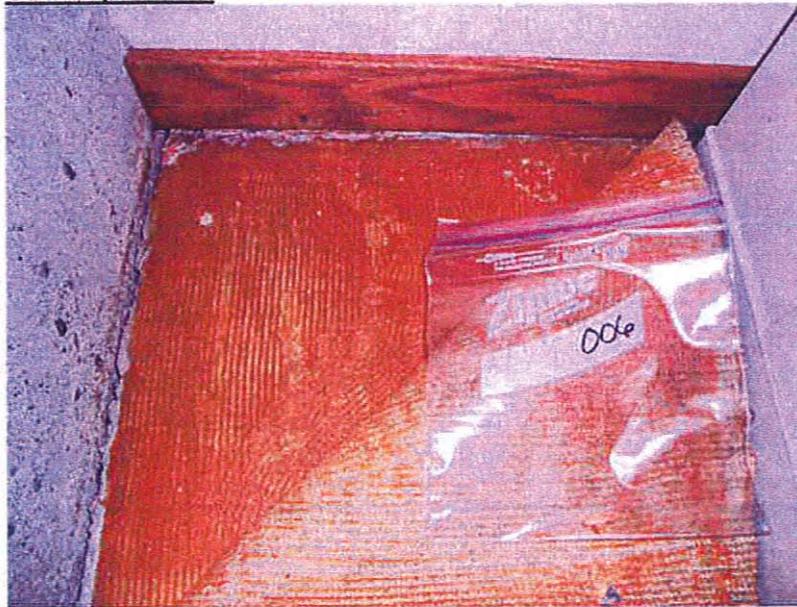
Gold Carpet Mastic

Description: Carpet Mastic

Material Location: First Floor Office

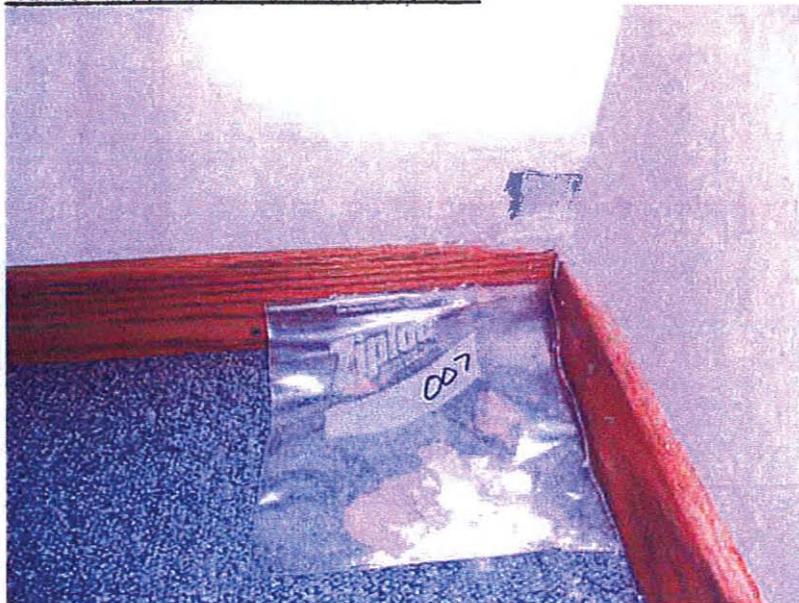
Wallboard and Associated Joint Compound

Description: Wall System

Material Location: First Floor Office
